Natural hydraulic limes for masonry repair: hydration and workability

Banfill, PFG, Forster, AM, MacKenzie, S, Pinilla Sanz, M, Szadurski, EM & Torney, C 2014, 'Natural hydraulic limes for masonry repair: hydration and workability', Paper presented at 34th Annual Cement and Concrete Science Conference, Sheffield, United Kingdom, 14/09/14 - 16/09/14 pp. 451-454.

P.F.G. Banfill, A.M. Forster, S. MacKenzie, M. Pinilla Sanz and E.M. Szadurski
School of the Built Environment, Heriot-Watt University, Edinburgh

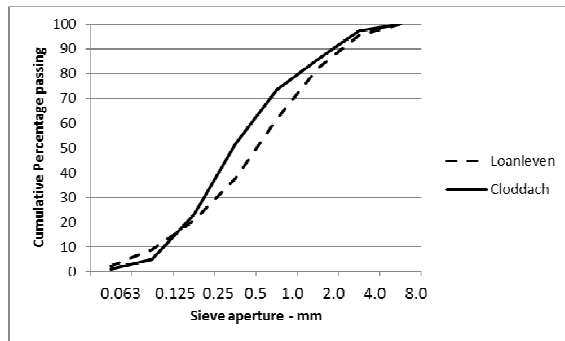
Two mortar sands were used – Loanleven, Perthshire, a mainly quartzitic sand, and Cloddach, Morayshire, predominantly granitic. Figure 1 shows that Cloddach's particle size distribution is slightly finer. Additionally,

Cloddach sand has a slightly lower bulk density and higher voids ratio than Loanleven sand.

Figure 1. Particle size distribution of the sands.

Figure 4 shows the relationship between flow and water/binder ratio for NHL3.5 limes with the two sands. Whilst the measured flow increases with increasing water/binder ratio, there is a complex interaction between the effect of type of binder and type of sand on the water/binder ratio needed for a particular flow. Hanson and Singleton Birch require less water when used with Cloddach sand than with Loanleven, whereas Otterbein and St Astier require more water with Cloddach sand than with Loanleven. As noted above, Cloddach is slightly finer with a lower bulk density and higher voids ratio than Loanleven sand. Table 2 gives the measured

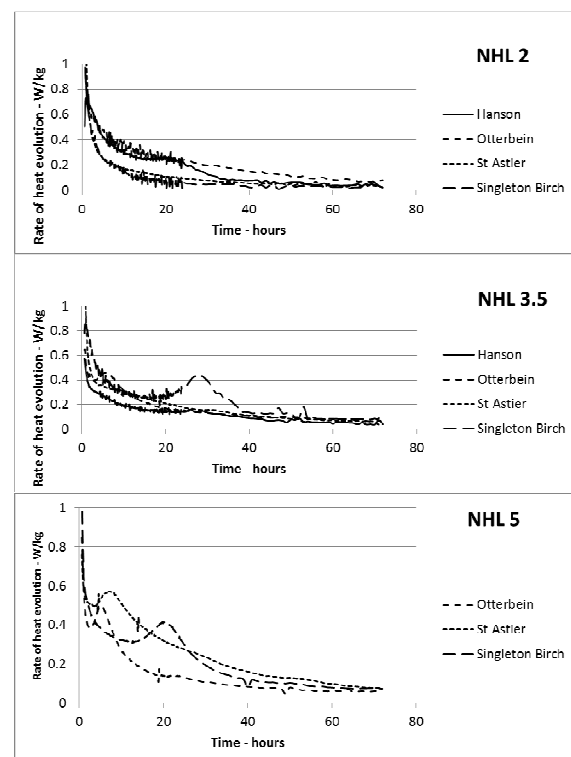
The rate of heat evolution over 72 hours for each of the natural hydraulic limes is shown in Figure 2.

Figure 2. Rate of heat evolution of NHL2s (top), NHL3.5s (middle) and NHL5s (bottom).

All the curves showed relatively high initial values due to the heat of wetting and the initial dissolution of free lime, although the rate of heat evolution is much less than is observed in cement. After this the rate of heat evolution decreases over time but with thermal events which are more pronounced in the NHL3.5 and NHL5 binders. Otterbein 3.5 and 5 showed a peak at about 5 hours, while St Astier 5 peaked at about 8 hours and Singleton Birch 3.5 and 5 peaked at 20-25 hours. The absence of thermal peaks in the NHL2 binders but their presence in the NHL3.5 and 5 binders is consistent with the hydraulicity differences: there is insufficient hydraulic matter in the NHL2s to show any

detectable hydration in the conduction calorimeter. The time of the later thermal events is consistent with the slow reaction of dicalcium silicate.

The rate of heat evolution of lime binders is considerably less than that of cements, for which the conduction calorimeter was designed, but differences between the limes are clearly visible. The total (cumulative) heat evolved over 72 hours hydration is at variance with the NHL classification assigned in the BS EN 459-1 hydraulicity test and this raises the important question of whether heat evolution would be a more discriminating test of hydraulicity.

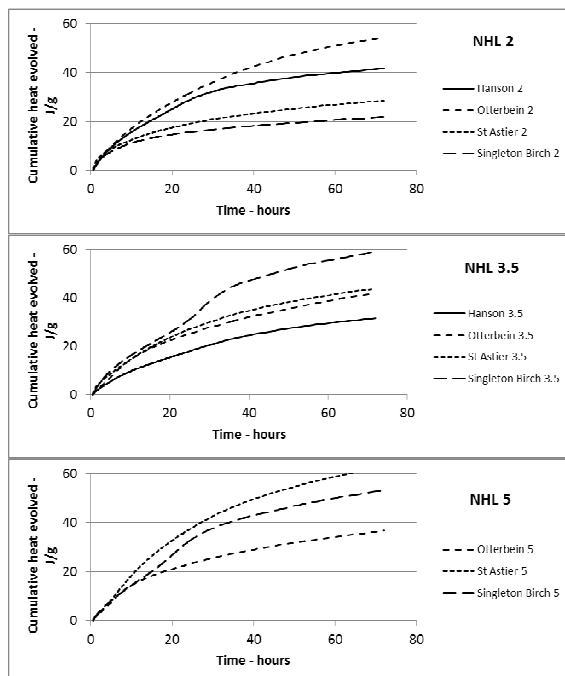
The cumulative heat evolution over 72 hours is shown in Figure 3. The results are not consistent with the grades assigned by BS EN 459-1. The cumulative heat evolved from limes of the same grade covers a range from a 2.5-fold difference (NHL2) through 1.9-fold (NHL3.5) to 1.7-fold (NHL5). Singleton Birch NHL3.5 and 5 are significantly more reactive than the others of the same grade, due to the heat evolution at 20-25 hours. Finally, Otterbein's cumulative heat evolved *decreases* from NHL2 to 3.5 to 5, but as expected from the heat evolution rate the cumulative trace rises rapidly at first and then more slowly.

Figure 3. Cumulative heat evolution of NHL2s (top), NHL3.5s (middle) and NHL5s (bottom).

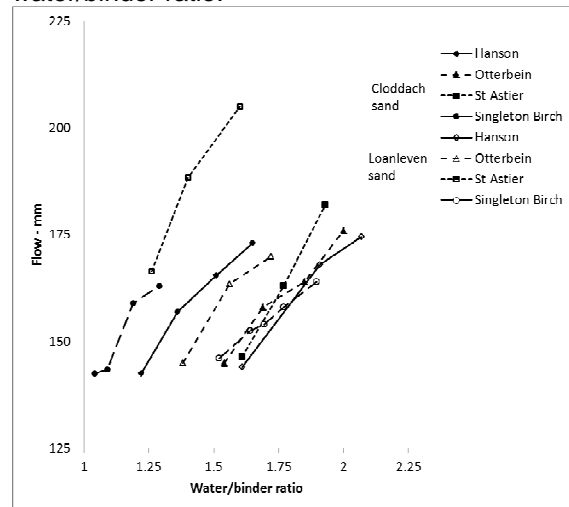
bulk density of each of the NHL3.5 limes but the differences do not explain the differences in water/binder ratio.

Figure 4. Effect of water/binder ratio on flow (NHL3.5).

Within an overall relationship with water/binder ratio, workability depends in a complex way on the physical properties of the binder and sand. This is particularly important because in practice mortars are proportioned by volume and the different bulk densities of the binder interacts with the voids ratio in the sand. Controlling workability by water content, as done in practice, may mean that specifying mortar by grade of binder may not achieve the expected properties: a binder of low bulk density may produce mortar of high water/binder ratio and poor strength and durability. Clearly data on mortars using NHL2 and 5 binders is needed to complete the story.

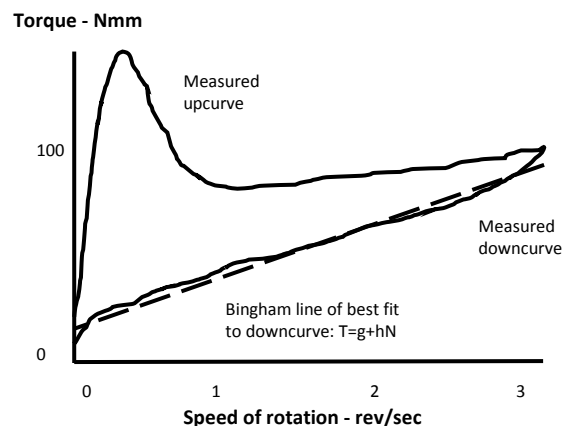
Figure 5 shows the general form of the flow curve of a lime mortar tested as described above in the Viskomat NT. The hysteresis loop between the up- and down-curves is due to the breakdown of structure formed by the flocculation of particles in water, and the parameters g and h , corresponding to yield stress and plastic viscosity respectively, are obtained by the best fit straight line through the points on the downcurve.

Figure 5. Flow curve for lime mortar in the Viskomat NT.

a cylinder containing the mortar was measured as the speed of rotation N increased to 200 rev/min over 2 minutes and decreased to zero again over 2 minutes. Mortars conform to the Bingham model, with the intercept g corresponding to the yield stress and the slope of the line h corresponding to the plastic viscosity:

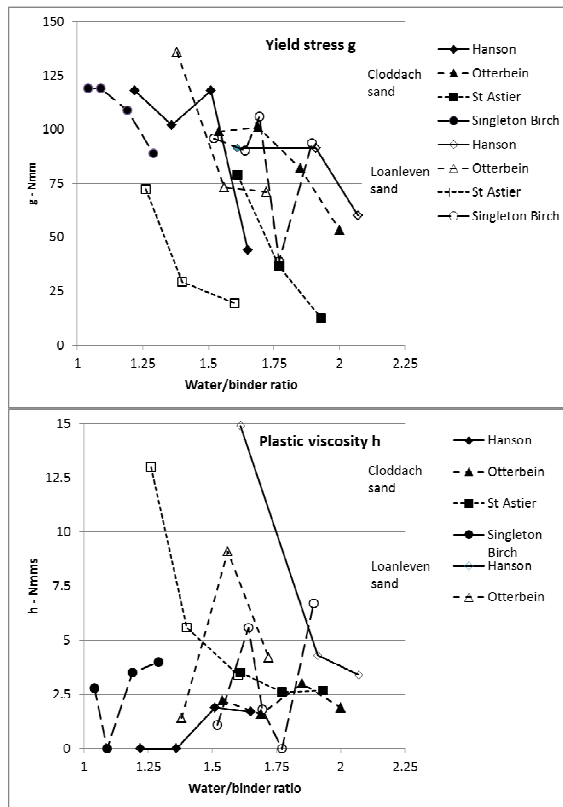
Figure 6 shows the relationship between yield stress, plastic viscosity and water/binder ratio for NHL3.5 limes with the two sands. In most cases the yield stress follows the expected

decreasing trend with increasing water/binder ratio [5] but only two plastic viscosity results show this effect. In part this is because some of the stiffer mortars tended to stick around the impeller and slip against the wall of the container: this tends to make the value unreliable. The same complex interaction between the effect of type of binder and type of sand on the water/binder ratio needed for a particular yield stress is visible.

Figure 6. Effect of water/binder ratio on g (top) and h (bottom).

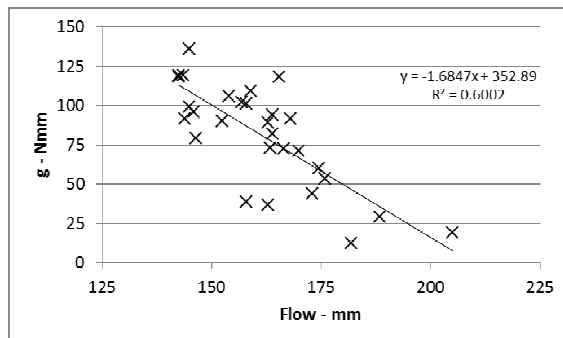
Figure 7 confirms the well-established relationship between yield stress and the single point tests like slump and flow which test the mortar at a low shear rate [5]. The negative correlation is significant but there is no correlation between plastic viscosity and flow.

Figure 7. Relationship between flow and g.
